Engineering Failure Analysis 10 (2003) 85–91

## Turbine blade failure in a thermal power plant

The failure of a LP (low pressure) turbine blade of a 220 MW thermal power plant is presented. The blade was made of martensitic stainless steel and the structure was tempered martensite. There was no evidence of degradation of blade material. The fracture took place at the aerofoil region, 113-mm from the root. Throughout the blade surface Si rich phases were detected. Several pits/grooves were found on the edges of the blades and chloride was detected in these pits. These were responsible for the crevice type corrosion. The probable carriers of  $\text{Cl}^-$  were Ca and K, which were found on the blade. The failure mode was intergranular type. Possibly the ultimate failure was due to corrosion-fatigue. © 2002 Elsevier Science Ltd. All rights reserved.

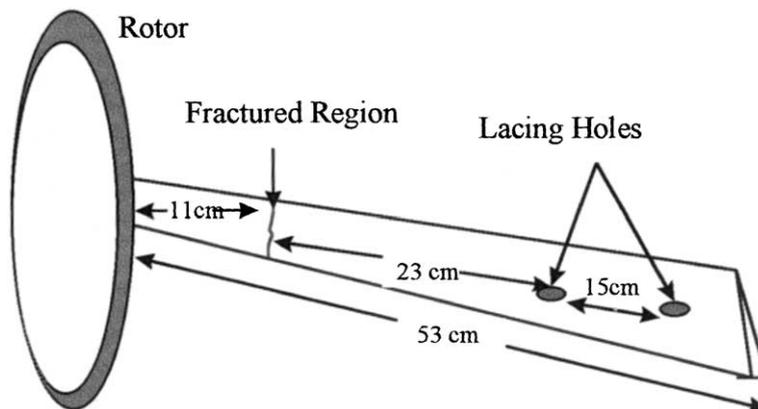
Chemical analysis of the blade material was carried out by a standard wet method. A portion of the failed blade with the fracture surface was cut for fractography study. A portion of the fractured blade (100 mm away from the fracture surface, as shown in Fig. 1) was cut for metallography. A few random pieces were also cut from the other two blades as already mentioned (i.e. 33,000 h service exposed and 100,000 h service exposed) for SEM and metallography. The metallography samples were prepared by using standard metallographic techniques and etched with Glycergia (a dilute solution of HCl, HNO<sub>3</sub> and glycerol). The microstructure of the blade material was analysed by optical microscope and a JEOL-840 scanning electron microscope (SEM) equipped with an energy dispersive X-ray (EDX) analysis facility. Hardness values were measured using a Vickers Hardness Testing machine under 10-kg load.

Fig. 1. Schematic of the turbine blade with the fractured region as shown.
