Physical deterioration of encapsulation and electrical insulation properties of PV modules after long-term operation in Thailand

C. Dechthummarong^{a,c,*}, B. Wiengmoon^{a,b}, D. Chenvidhya^{a,b}, C. Jivacate^{a,b}, K. Kirtikara^{a,b}

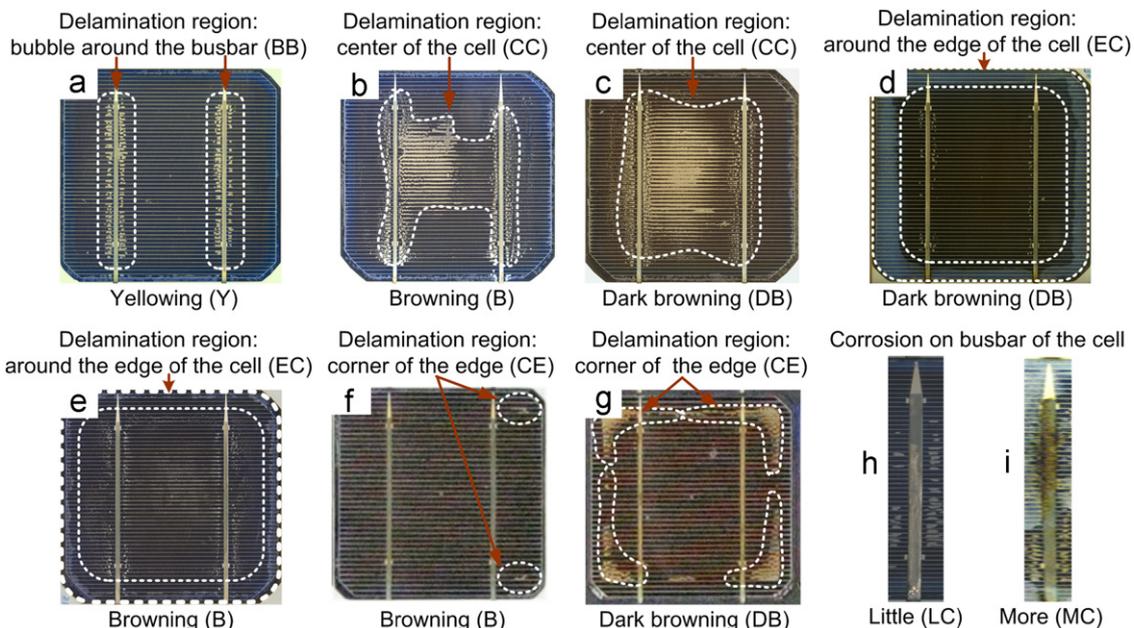
The physical deteriorations in front of the module are shown by the photographs in Fig. 2a–i. It is interesting to note that the key defects were discoloration, delamination, and corrosion on the busbar of the cell. The three levels of EVA discoloration were yellowing (Y), browning (B), and dark browning (DB). The dominant delamination formations had four patterns that were bubbles near the busbar (BB), at the center of the cell (CC), around the edge of the cell (EC), and at the corner of the edge on the cell (CE) as shown in Fig. 2a–g. However, corrosion on the busbar of

Fig. 2. Photograph of the physical deteriorations in front of the PV modules: (a) Y, BB, (b) B, CC, (c) DB, CC, (d) DB, EC, (e) B, EC, (f) B, CE, (g) DB, CE, (h) LC, and (i) MC.
