Safety analysis of modern heritage masonry buildings: Box-buildings in Recife, Brazil

Jenner Carvalho^a, Javier Ortega^b, Paulo B. Lourenço^{b,*}, Luís F. Ramos^b, Humberto Roman^a

Box-buildings are structural masonry buildings named as such because of their shape. There are around 5000 of them in Recife, Brazil. This paper presents a safety analysis of one box-building that suffered collapse on December 2007. The research aims at quantifying the safety of this type of existing buildings and at better understanding their structural behavior to try to identify the reasons for the collapse. A finite element model was prepared and a set of nonlinear numerical analyses were performed. The results of the analyses show good agreement between the observed damage in the real building and the damage achieved numerically at the current condition ($LF = 1$). The model thus seems to represent satisfactorily the real behavior of the building but the safety factor obtained seems too conservative and does not justify the collapse observed in reality. Since results show that the building should not have failed under normal working conditions, a collapse assessment about why the building fell is

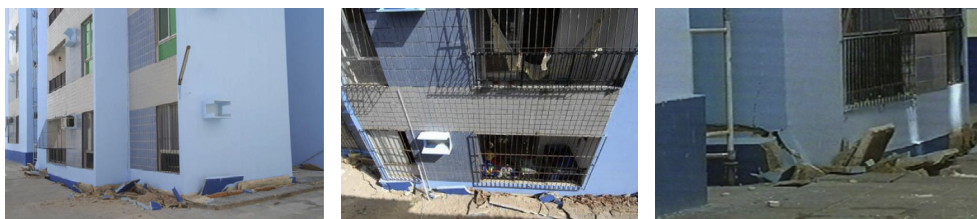
The research is focused on one of the box-buildings of the residential complex *Sevilha*, in *Jaboatão dos Guarapes*, within the RMR. The residential complex is composed by four blocks of very similar characteristics. Block B partially collapsed on December 2007 and it was later demolished. Fig. 1 shows the building after the collapse. Failure of the foundation masonry walls was observed. This collapse triggered the experimental and numerical research carried out by de Carvalho [8]. The visual inspection and testing program described next was performed on the block C of the complex.

Fig. 1. Views of the building after the collapse.
