## Safety analysis of modern heritage masonry buildings: Box-buildings in Recife, Brazil

Box-buildings are structural masonry buildings named as such because of their shape. There are around 5000 of them in Recife, Brazil. This paper presents a safety analysis of one box-building that suffered collapse on December 2007. The research aims at quantifying the safety of this type of existing buildings and at better understanding their structural behavior to try to identify the reasons for the collapse. A finite element model was prepared and a set of nonlinear numerical analyses were performed. The results of the analyses show good agreement between the observed damage in the real building and the damage achieved numerically at the current condition ( $LF = 1$ ). The model thus seems to represent satisfactorily the real behavior of the building but the safety factor obtained seems too conservative and does not justify the collapse observed in reality. Since results show that the building should not have failed under normal working conditions, a collapse assessment about why the building fell is therefore provided and a sensitivity analysis was performed in order to understand the impo

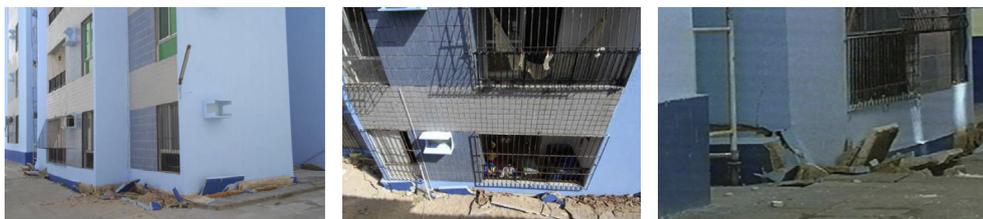
The research is focused on one of the box-buildings of the residential complex *Sevilha*, in *Jaboatão dos Guarapes*, within the RMR. The residential complex is composed by four blocks of very similar characteristics. Block B partially collapsed on December 2007 and it was later demolished. Fig. 1 shows the building after the collapse. Failure of the foundation masonry walls was observed. This collapse triggered the experimental and numerical research carried out by de Carvalho [8]. The visual inspection and testing program described next was performed on the block C of the complex.

Fig. 1. Views of the building after the collapse.
