6th International Building Physics Conference, IBPC 2015

Deterioration of the wall of a historic stone building in a cold region and measures to protect it

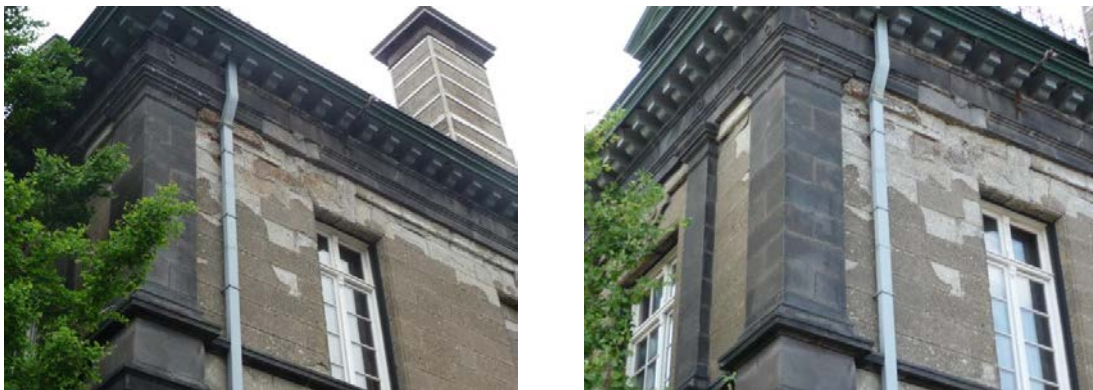
Fig. 2 shows the deteriorated condition of the walls facing north and east. The left photo was taken in June 2009 and the right photo was taken in October 2011. The white parts are places where the surface stone had peeled off or fallen. These pictures show that the surface area of the deteriorated parts rapidly increased in about 2 years.

Fig. 2 Deterioration of stone wall surface (left: June 2009, right: October 2011)
