# Corrosion rate evaluation by gravimetric and electrochemical techniques applied to the metallic reinforcing structures of a historic building

José I. Iribarren<sup>a,\*</sup>, Francisco Liesa<sup>b</sup>, Carlos Alemán<sup>a,c</sup>, Elaine Armelin<sup>a,c,\*</sup>

This work presents the diagnosis procedure followed to determine the degree of damage of a 100-year-old reinforced concrete building located in Barcelona city, the *Sant-Manuel* pavilion at *Hôpital de la Santa Creu i Sant-Pau*. Some structural components of this building were affected by severe corrosion problems in the reinforcing steel UPN profiles. In order to obtain a representative sample set, a preliminary inspection of the macroscopic architectural structure was applied at selected zones that exhibited the metallic backbone. Gravimetric and electrochemical techniques have demonstrated that some UPN profiles presented high corrosion rate. This was mainly due to the presence of water pipes installed beside the metallic structure, which was a source of humidity, and also to the presence of calcium carbonate, calcium silicate hydrate, and calcium chloride substances inside the cement in direct contact with the me

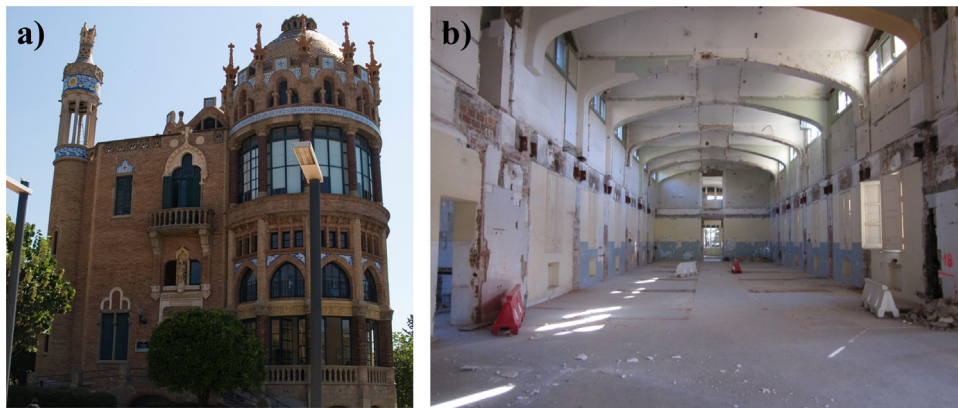
Fig. 1. (a) Photograph of *Sant Manuel* pavilion nowadays and (b) general view of ground floor at the beginning of restoration.

The present work is related with the evolution of the corrosion process in the metal profiles used in the *Sant-Manuel* pavilion building (Fig. 1a) and with the degradation of neighbourhood cement in contact with them.

The protocol followed was supported by an experimental methodology including a preliminary overall inspection of general status of building structure (Fig. 1b), in particular of metallic skeleton. The random selection of different pillars and beams of carbon steel was carried out to pull a specimen collection to be tested in accordance with gravimetric and electrochemical methodology in order to estimate the corrosion degree. Complementarily, composition of carbon steel and surrounding cement was examined to obtain the influence of possible pollutants in corrosion of carbon steel.

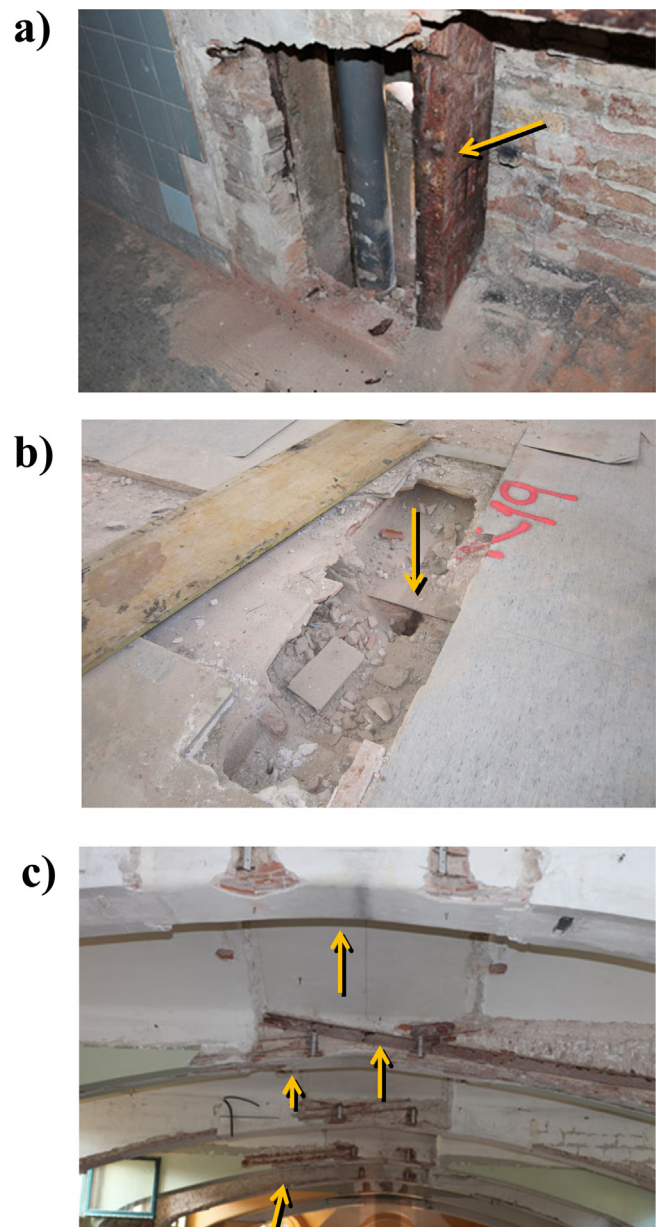
The metallic structure of this building is made from UPN profiles of steel (UPN100, UPN200 and UPN300) placed as pillars, beams and reinforcing struts dome (Fig. 2). Although there are other profiles in horizontal arrangement on the side walls, these were not considered for analysis because they do not constitute basic elements of structure (Fig. 3). The metallic profiles are not visible except for the sample extraction in selected zones where excess of iron oxides are present on the surface. Then, the reinforced steels were cut in the appropriate size by engineers working in the restoration of *Sant-Manuel* pavilion, from the selected zones, shown in the Fig. 2, whereas others samples needed to be extracted from zones cemented.

Fig. 2. Metallic structures based on pillars (a), beams (b) and purlin from roof truss (c). Arrows indicate the zones where the corroded profiles are located.
