Fusion Engineering and Design

Implementation of ferritic steel as in vessel wall: Lessons learnt and follow up

ASDEX Upgrade (AUG) is the only tokamak in Europe to have low activation ferritic steel as the inner vessel wall facing component. Together with the massive tungsten tiles in the lower divertor, AUG is the tokamak with the closest DEMO wall. The project is a first step towards the extensive use of ferritic steel in future fusion reactors. For example, the test blanket module of ITER is planned to have a ferritic steel wall and thick tungsten tiles as a plasma facing component.

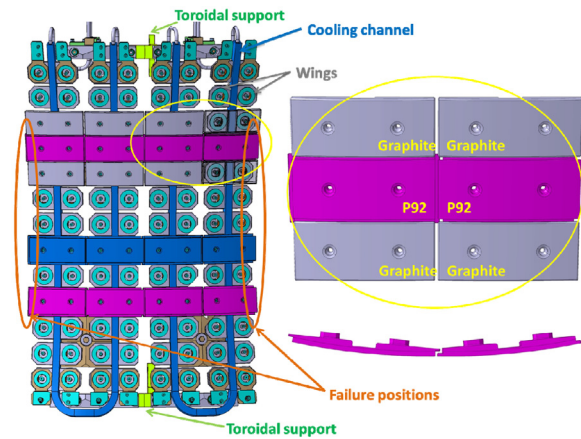
Fig. 2. View of the 2 adjacent HS supporting structures belonging to a VV octant: ferromagnetic tiles installed first are in pink, the row installed in 2015 is in blue. The gray tiles are made of graphite. On the right hand side a detailed view of the tiles set up is shown: a labyrinth feature has been implemented together with the P92 tiles.

At first, our thoughts were completely focused on the new material. A deep examination of the damage configuration revealed that the HS supporting structure was moving inside AUG. In fact, the above mentioned damages were all placed between 2 VV octants (orange regions in Fig. 2). Broadening our view, it was assumed that during a disruption with plasma displacement, the variation of the radial field could induce a current flowing in 2 adjacent HS supporting structures.

All the steel tiles, together with their contiguous graphite tiles, have been redesign with a labyrinth feature (e.g. in Fig. 2) in order to reduce the ECRH stray field [3].

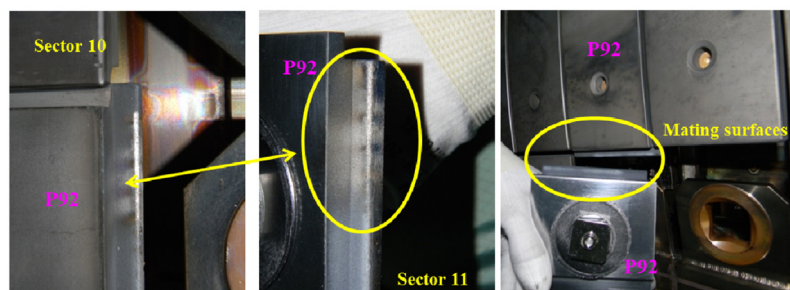
After the first campaign with the 2 steel rows, the inspection of the in vessel components disclosed some unexpected damage of the HS tiles. In particular, some steel tiles exhibited a coating failure as clear indication of a possible contact against the adjacent tiles. Some of them were burned along their poloidal edges. These damages are shown in Fig. 3. Some of these steel tiles also had melted areas in the sectors placed opposite to Neutral Beam Injectors. The striking findings were observed on the graphite tiles adjacent to the P92 tiles. In many locations, the graphite tiles showed notches and in 5 positions their edges were broken (e.g. in Fig. 4).

Fig. 3. Damages on the P92 tiles in AUG: on the left hand side are shown the arc damages and on the right hand side the mating contact surface between tiles.
