Seismic rehabilitation of semi-rigid steel framed buildings—A case study

H. Shakib^{a,*}, S. Dardaei Joghān^a, M. Pirizadeh^a, A. Moghaddasi Musavi^b

This paper presents the seismic vulnerability and rehabilitation of a steel building with semi-rigid connections in Tehran. This 19-storey building with an asymmetric plan was constructed 30 years ago in three blocks. The qualitative vulnerability of the building was evaluated in the first step of the study, indicating its high seismic vulnerability. In the next step of the study, the quantitative vulnerability of the structure was investigated. The results show that the building was strong enough to resist gravity loads but the strength was not adequate for seismic loads. Finally, three seismic retrofitting methods consisting of concrete shear wall, steel shear wall, and steel bracing were proposed. The comparison of the three retrofitting alternatives in terms of architecture, implementation, and seismic performance showed the superiority of using the concrete shear walls over the two other alternatives.

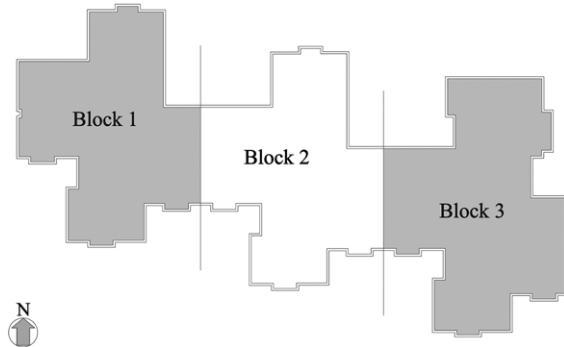
The building investigated was designed and built between 1973 and 1978. As illustrated in Fig. 1, the building had 3 rather similar

blocks. There was a distance of about 21 cm between the blocks. The blocks consisted of 19 stories: 3 underground stories, the ground floor and 15 stories on the ground. The area of each storey was approximately 1950 m². The three underground stories were used as car parking areas and the upper floors, being offices for roughly 2000 people, had an administrative usage. The typical storey height was 3.2 m. The southern view of the building is shown in Fig. 2.

**Fig. 1.** Position of three blocks of the building.

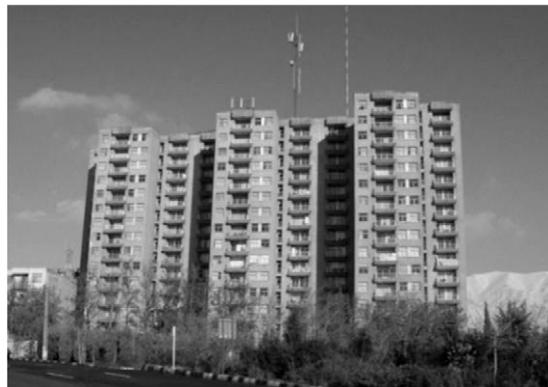
**Fig. 2.** The southern view of the building.
