Journal of Constructional Steel Research

Evaluation of a steel railway bridge for dynamic and seismic loads

Ozden Caglayan, Kadir Ozakgul*, Ovunc Tezer, Erdogan Uzgider

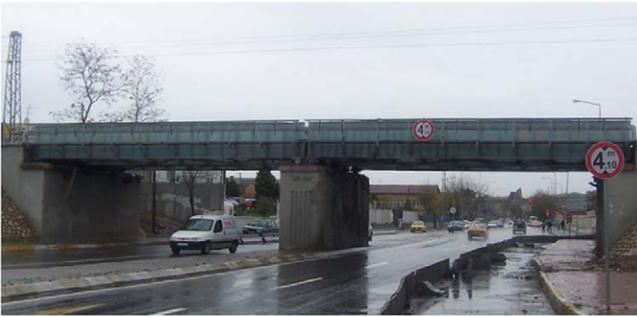
Fig. 1. A general view of the bridge.

The bridge is located approximately 10 km from historical Sirkeci railway station which is the starting point of Europe-directed railway track in Istanbul. It was designed and built in late 1960s by TCDD (Turkish Railways Administration) which is the governmental authority of the country. The bridge is situated in metropolitan area of the city and is subject to heavy traffic of passenger transportation, mainly suburban commuter trains. As shown in Fig. 1, the bridge is composed of four simply supported spans, each with riveted steel plate girders, an open deck, stringers and cross beams. The layout of the bridge is given in Fig. 2. Each span has a length of 13.5 m.

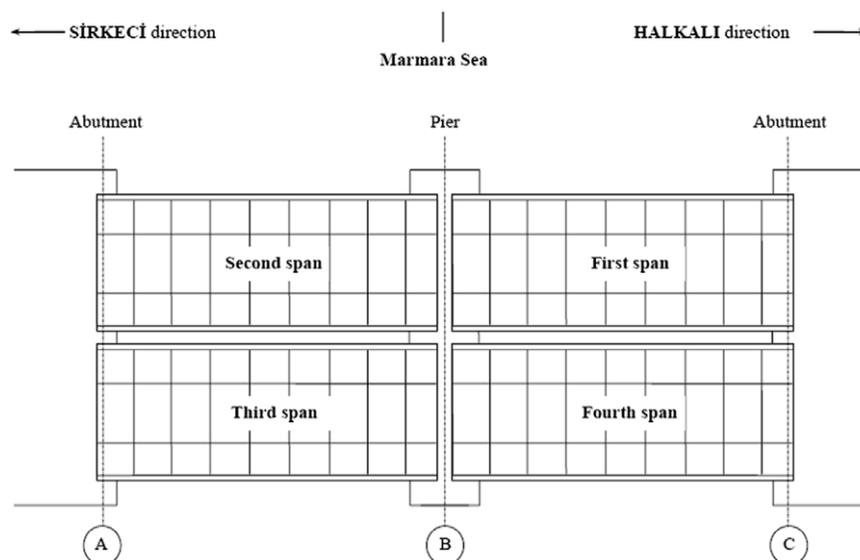
Fig. 2. Layout of the bridge.
