The historical turf farms of Iceland: Architecture, building technology and the indoor environment

Abstract

Keywords: Iceland; Farmhouse; Vernacular architecture; Turf; Indoor environment; Building technology

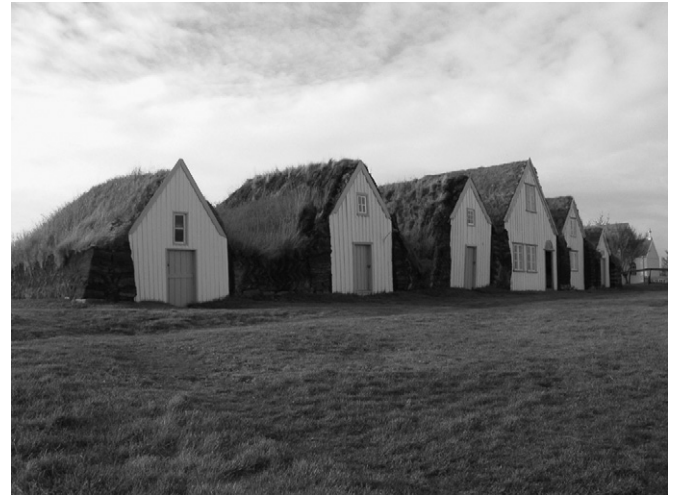
Fig. 1. Glaumbær, an example of Icelandic turf architecture.

The case study was carried out on Glaumbær farm (Fig. 1), a former parsonage and a representative example of Icelandic turf architecture situated on the Skagafjörður in the north of the country. This compact building, constructed between 1750 and 1879, is one of the largest and oldest turf farms in existence, and is in use as a folk museum. The farm consists of 13 rooms along a central 23 m long corridor (Fig. 2). At the end of this corridor, the *baðstofa* (a room, which served as both a living and bedroom) is situated (Fig. 3). The room measures 52 m² and has four small dormer windows (together 1.3 m²) facing west. The volume (34 m³) was limited due to the small height. One could just sit straight up in bed, and stand upright in the middle of the room. In this room the occupants of the farm spent most of their time indoors. To the south was a small vegetable garden enclosed by an

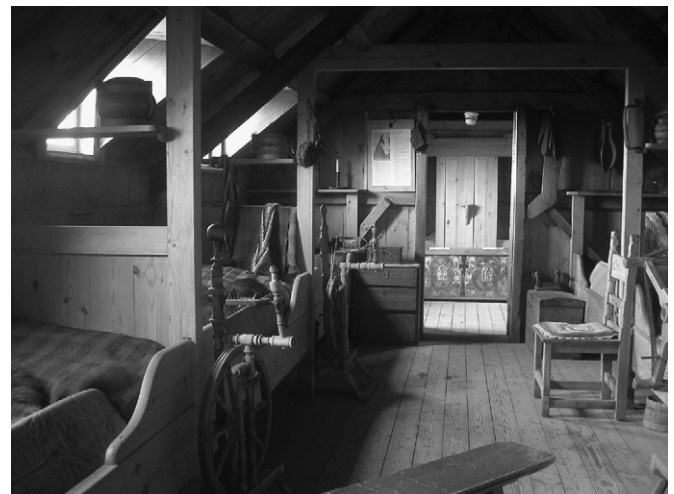
Fig. 3. Impression of the *baðstofa* of Glaumbær.
