Learning from the past to protect the future: Armature Crosswalls

Randolph Langenbach*

Conservationtech Consulting, Oakland, CA, USA

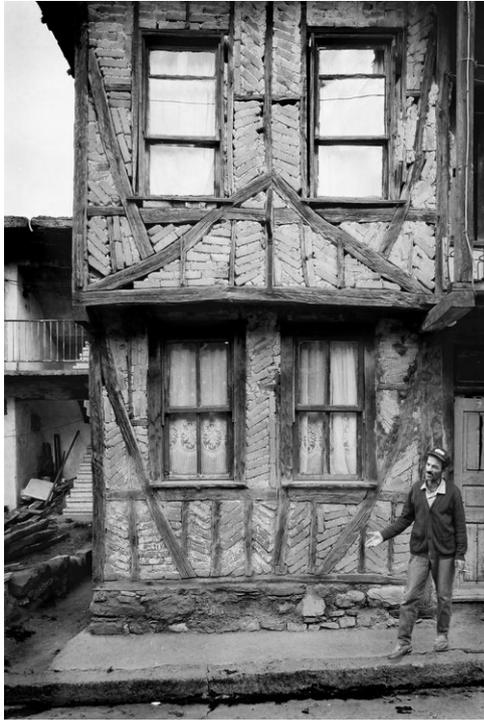
Fig. 1. This long abandoned and unmaintained 2.5 story *humuş* house in Gölcük survived the 1999 earthquake with little additional damage, despite the widespread collapse of the surrounding RC structures.

The superior performance of many traditional timber and masonry buildings over newer ones of reinforced concrete during recent earthquakes in Turkey, India (Gujarat and Kashmir) and Pakistan raises fundamental questions about the assumptions made over many decades that simple, unsophisticated, non-engineered, timber and masonry structures (seemingly more medieval than modern) are less safe in large earthquakes than newer structures of reinforced concrete (RC). Despite the frequently abysmal record of contemporary RC structures under seismic loading, certain types of traditional masonry structures with timber-lacing have survived the same earthquakes with only minor damage. This gives rise to the question of whether one can employ aspects of traditional technology Fig. 1 to enhance the seismic performance of modern constructions.

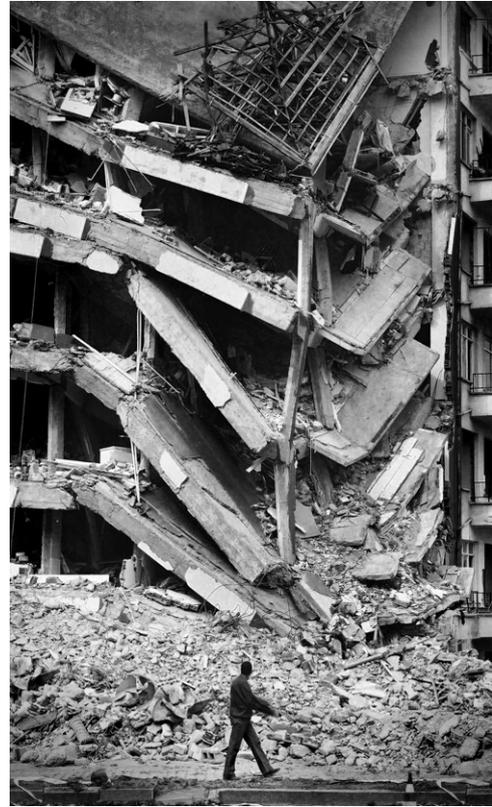
Fig. 2. Partially collapsed RC frame with infill masonry apartment block, Gölcük, Turkey, 1999.

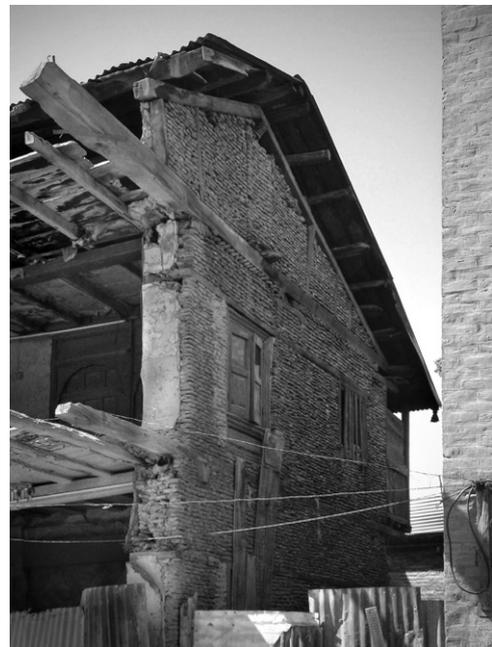
Fig. 3. Partially demolished *taq* construction (Srinagar, Kashmir, 2006) showing timber lacing laid into the wall. Timber bands at floor level and at the window lintel levels.
