Reverse engineering methodology for studying historic buildings coatings: The case study of the Hellenic Parliament neoclassical building

M. Karoglou*, A. Bakolas, N. Kouloumbi, A. Moropoulou

National Technical University of Athens, School of Chemical Engineering, Zografou Campus, 15780 Athens, Greece

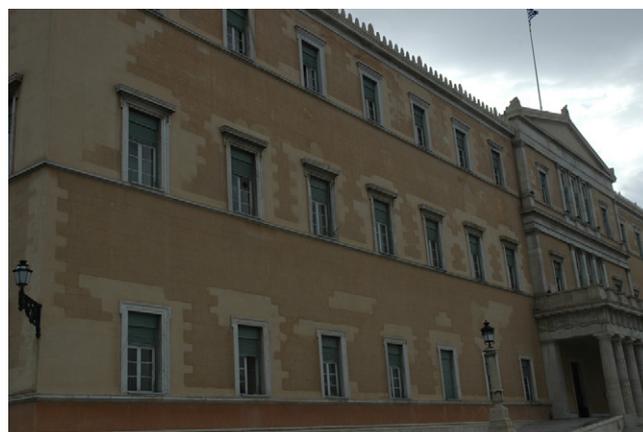
Fig. 2. Different restoration materials finished at west façade of the Greek Parliament.

The diagnostic campaign started with the visual analysis of the Parliament façades. The building façades coatings consisted of materials of different appearance, especially in the areas around windows, causing an image of "patchwork". It was crucial to define the exact sites of the original and restoration materials. As it can be seen in Fig. 2, the various coatings presented noticeable differences in texture and colour, but all of them were produced in a way to create an imitation of "stone". In Fig. 3 the imitation of stone units is clearly resulted through the use of graphite for depicting mortar joints. Discolouration areas of materials surface were also detected.
