Substitution ventilated render systems for historic masonry: Salt crystallization tests evaluation

Ana Fragata^{a,b,*}, M. Rosário Veiga^a, Ana Velosa^b

^a National Laboratory for Civil Engineering, Buildings Department, Av. Brasil, 101, 1700-066 Lisbon, Portugal

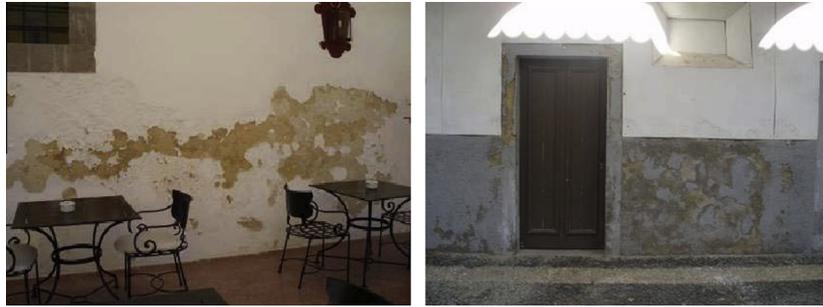
Fig. 1. Decay of renders on the walls due to the presence of soluble salts.

When water rise is associated with the presence of soluble salts, the result may be particularly severe with an extensive decay of the masonry materials and/or of the renders on the walls (Fig. 1).
