Materials decay and environmental attack in the *Pio Palace* at Carpi: A holistic approach for historical architectural surfaces conservation

Since the XIV century the Pio Palace in Carpi (MO, Italy) has been subjected to many additions and rearrangements and, in the last decades, to wide restoration works. Nevertheless the XVII century main portal has not been restored yet, due to its complex and peculiar surface alteration forms in comparison with the other parts of the building, and still suffers a deep decay and degradation by complex chemical-physical processes.

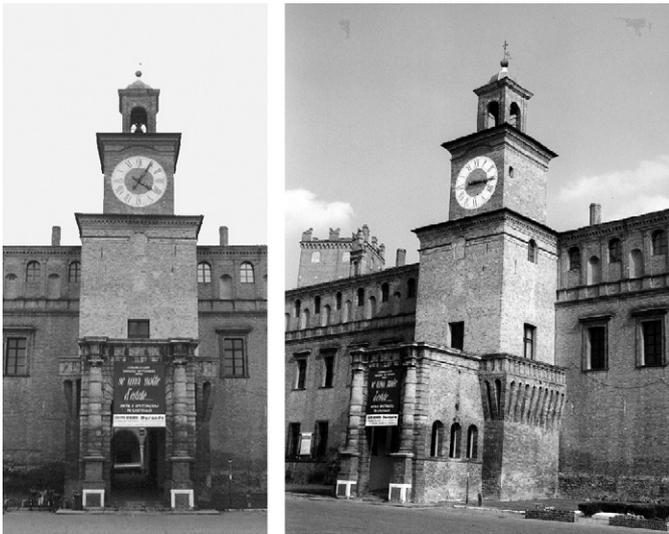
Fig. 2. The clock tower at the Palace main entrance.

In the years 1997–1998 the tower went through an overall restoration intervention, involving cleaning, substitution of the damaged bricks and the mortars external layers, creation of a barrier against water capillary rise by resin injection, application of a macroporous plaster on the internal surfaces of the walls, etc. Only the ashlar-worked (“*bugnato*”) brick portal, suffering from a deep decay with no similarity in any other parts of the building, was kept out from that restoration and left in its former state (Fig. 2). At present, the portal, which represents the monumental entrance to the building, needs effective works for its safeguard. Diagnostic investigations have therefore been carried out to disclose the causes of its heavy and peculiar deterioration (Fig. 3), using a multidisciplinary approach. This approach allowed to outline an integrated diagnostic protocol taking into account all possible external (moisture, environment, wind, etc.) and bulk (materials and manufacturing technology, microstructure and its transformations, etc.) causes, as well as historically proved transformations, which may lead to such a complex decay of architectural external surfaces.

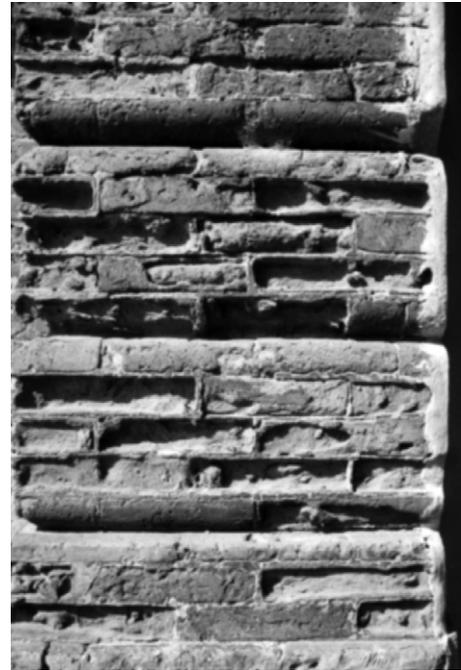
Fig. 3. Decay of the bricks in the portal of the clock tower.
