# Effect of corrosion on the tension behavior of painted structural steel members

The long-term structural performance of steel structures can be directly related to corrosion. In this study, tensile tests were conducted on corroded steel members to examine the effect of corrosion damage on their tensile behavior. For this purpose, tension specimens were manufactured using the members of a 75-year-old painted steel bridge exposed to the marine environment. The corroded surfaces of the tension specimens were measured using an optical 3D digitizing system to obtain their residual thicknesses. After the tensile tests were performed, the characteristics of the tensile behavior of the corroded steel plates such as the yield load, ultimate load, and elongation were evaluated quantitatively. An effective thickness has been suggested using the mean and standard deviations of the residual thicknesses of the specimens. This can be used to evaluate the tensile strength of a structural steel member with an irregularly corroded surface. The practical measurement intervals for taking the various thickness measurements of the corroded steel members are also presented.

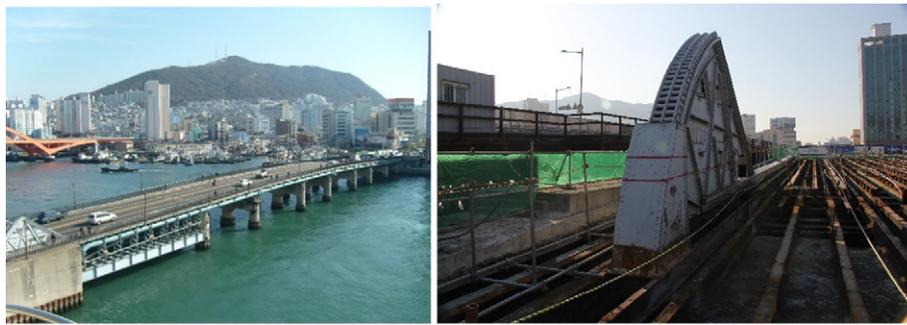
(a) Before and after demolition of the 75-year-old Yeongdo Bridge.

Fig. 1. Location, environment, and corroded members of the Yeongdo Bridge.

the tensile test specimens were procured from a demolished steel bridge that had a service life of approximately 75 years (1934–2009). The bridge had been erected in a coastal area with high salinity. The steel plate was made of structural steel and was 400 mm long and 60 mm wide. The chemical composition of the steel is shown in Table 1. As per ISO 12944 [17], the corrosivity category of the steel bridge is classified as very heavy (C5-M), which represents the highest level of corrosion.

Fig. 1(a) shows the steel bridge before demolition and its dismantled members. The specimens for the tensile test were selected from the stringers and connection plates of the dismantled steel bridge members as shown in Fig. 1(b).

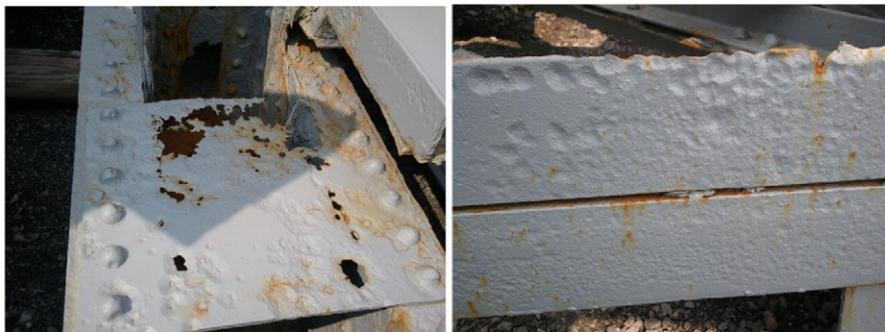
(b) Pictures of the corroded members of the Yeongdo Bridge

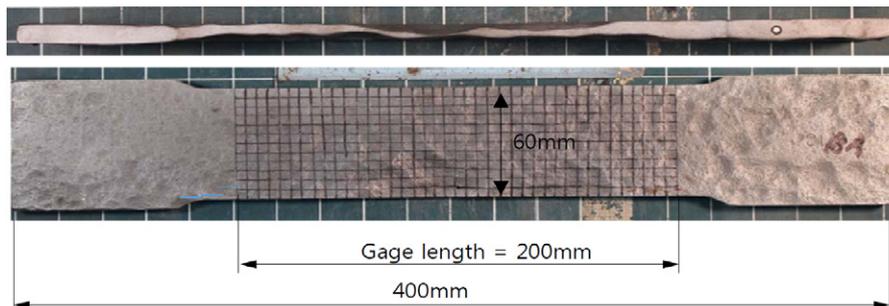
Fig. 2. A typical tensile test specimen.

In this study, the tensile specimens that were originally taken from the Yeongdo Bridge were reprocessed according to KS B0801 [18]. Fig. 2 shows the dimensions of a typical specimen. In addition to the seventeen corroded tensile test specimens, three non-corroded
