11th International Conference Interdisciplinarity in Engineering, INTER-ENG 2017, 5-6 October 2017, Tirgu-Mures, Romania

## Study on the acoustic rehabilitation of a church

### Abstract

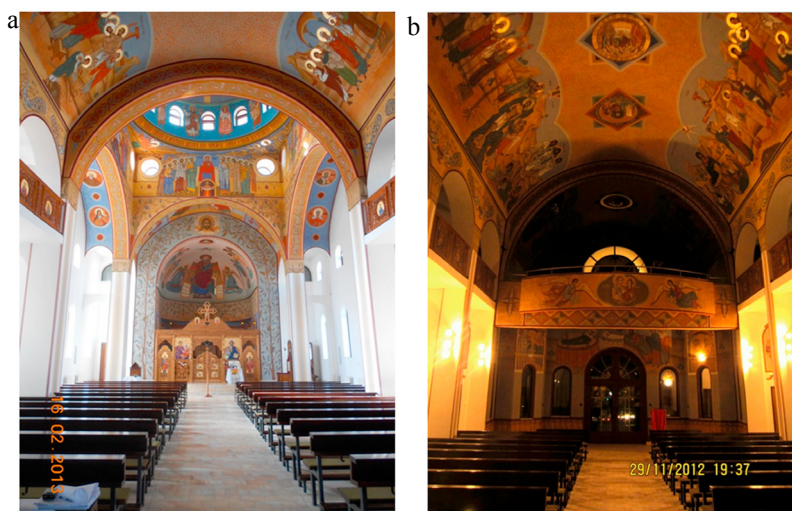
The analyzed church is located in Cluj-Napoca municipality, Romania, having a Greek Catholic rite. The construction of the church was made over several years, starting with 1996 until 2007. The building itself presents a complex geometry involving domes or vaults. It has a maximum length of 39.00 m and a maximum width of 21.05 m. The audition hall, with a height of 18.05 m in the central dome, has a volume of approx. 3000 m<sup>3</sup> and a capacity of 245 seats. The liturgical activity takes place on the ground floor of the building and first floor, where a balcony designed for the choir members is placed (Fig 1).

Fig. 1. Audition hall interior: (a) orientation towards altar; (b) orientation towards balcony.

The resistance structure of the building is made of reinforced concrete frames infilled with brick masonry walls. Interior walls are plastered and painted. The upper enclosing elements and the altar are painted with frescoes. The ground floor slab is covered with marble and the balcony with ceramic floor tiles. Interior furnishing consists of benches and chairs made of wood. Windows and doors are realized of PVC profile.
