An experimental investigation of the nature of longitudinal cracks in oil and gas transmission pipelines

Oil and gas pipeline maintenance and monitoring are of utmost importance. Therefore, being aware of the pipeline conditions, predicting their failure, planning to manage emergencies and evaluating their conditions are essential. In this study, Magnetic Particle test inspection was performed on a 52-year-old, 6 inch steel pipeline, which was primarily used as an oil transmission pipeline but was repurposed to a gas transmission pipeline later. Longitudinal cracks were found on the pipes during the inspection. Several tests were conducted aiming to clarify the nature of these cracks. The tests included chemical analysis, tensile test, impact test, hardness measurement to determine the type of steel, soil tests to specify the elements present in the soil and to evaluate corrosion conditions of the soil, SEM imaging, optical microscopy, and Energy-Dispersive X-ray Spectroscopy (EDS). The steel was found to be of X46 grade and the tests did not suggest the presence of aerobic as well as anaerobic bacteria in the environment. Moreover, the EDS results did not show any signs of corros

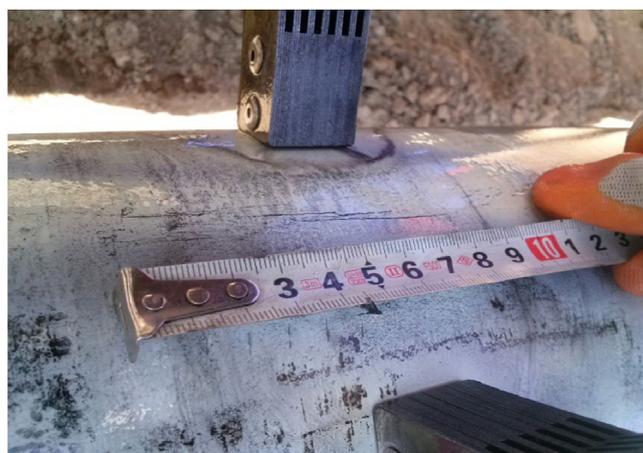
The pipeline was excavated in a number of locations and longitudinal cracks were found (Fig. 1). Observations suggest the presence of these cracks all across the course of the pipeline. It is evident from Fig. 1 that the longitudinal cracks are as long as 4 cm in some parts of the pipe. Additionally, no sign of corrosion was seen in the visual inspection of the external surface of the sample, and the coating adhesion to substrate was acceptable, which can be a result of favorable cathodic protection.

Fig. 1. Cracks detected on the steel pipeline by Magnetic Particle Inspection.
