### Construction and Building Materials

## Experimental response of historic brick masonry under biaxial loading

#### R. Capozucca

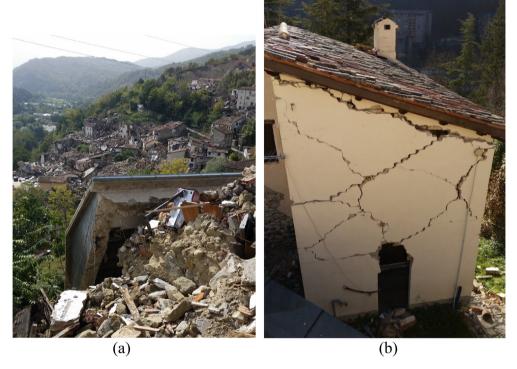
Fig. 1. (a) Collapse of historical building-Pescara del Tronto, Italy; (b) shear damages of a building in Visso, Italy, 2016.

elements; in such structures, forces induced in buildings subjected to earthquakes are transferred from floors to panels. If HURM buildings are well organised with load-bearing and shear walls linked to the floors, this structural organisation, together with adequate strength masonry materials may allow resisting horizontal seismic loads [1]. It is important to underline that floors play a very important role by preventing the separation and out of plane collapse of walls orthogonal to seismic action, thus avoiding the rotation and consequent collapse of walls due to loss of equilibrium. Notwithstanding the presence of rigid floors, HURM buildings reached sudden collapse (Fig. 1(a)); the collapse of a part of a masonry building or, in even worse cases, of entire buildings, was in particular caused by the low strength of the materials used; materials which did not allow reaching shear mechanism. On the other hand, from observations following earthquakes, it appears that many HURM buildings without rigid floor in plane and built using timber beams, resisted the effects of earthquakes because of horizontal tie-beams and the adequate strength of the materials employed (Fig. 1(b)). Safe behaviour of HURM buildings can be
