Engineering Failure Analysis

Seismic assessment of two masonry Baroque churches damaged by the 2012 Emilia earthquake

Marco Valente*, Gaia Barbieri, Luigi Biolzi

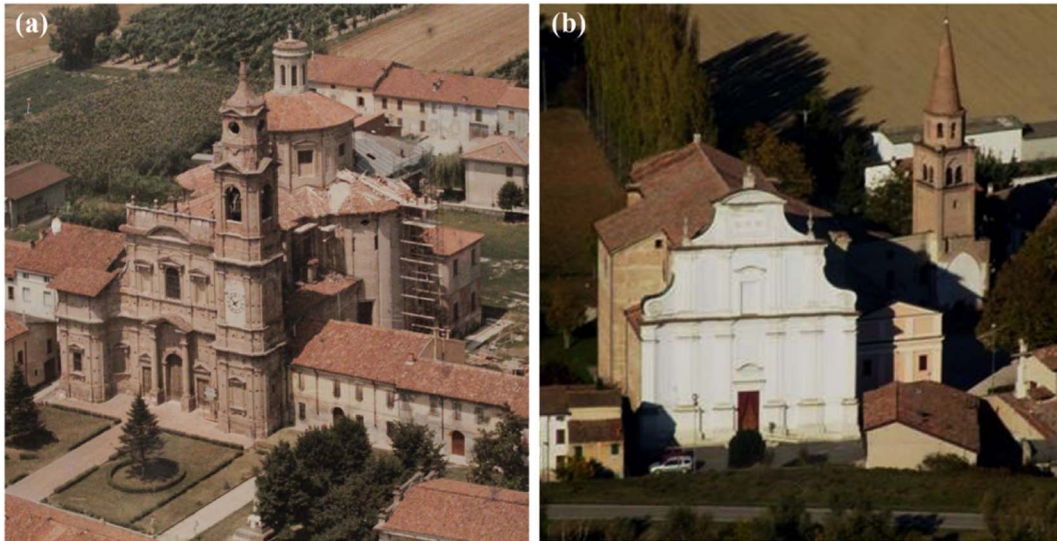
Fig. 1. General view of the two churches under study: (a) Sant'Antonio Abate church in Villa Pasquali; (b) San Erasmo and Agostino church in Governolo.

Two masonry Baroque churches located in the province of Mantua are analyzed in this study: 1) Sant'Antonio Abate church in Villa Pasquali; 2) San Erasmo and Agostino church in Governolo. The two churches suffered a significant and different damage after the seismic events of May–June 2012. Fig. 1 shows a general view of the two churches under study. These buildings have been selected because they can be considered valuable examples of Baroque architecture in the province of Mantua. In particular, the importance of Sant'Antonio Abate church is due to the prestige of its architect, Antonio Galli da Bibiena, and to the peculiar system of masonry perforated vaults, which is an unicum in architectural history, as underlined also in a previous study presented by the Authors [32]. Nevertheless, until now the two churches have not been studied and one of the aims of this study is to give a valuable contribution to fill the gap of knowledge about these two churches.
