# Learning from the past to protect the future: Armature Crosswalls

Randolph Langenbach\*

## Abstract

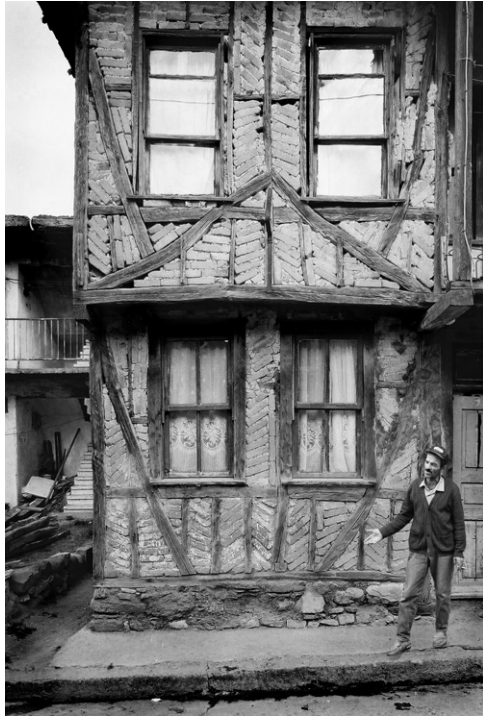
Fig. 1. This long abandoned and unmaintained 2.5 story *humuş* house in Gölcük survived the 1999 earthquake with little additional damage, despite the widespread collapse of the surrounding RC structures.

The superior performance of many traditional timber and masonry buildings over newer ones of reinforced concrete during recent earthquakes in Turkey, India (Gujarat and Kashmir) and Pakistan raises fundamental questions about the assumptions made over many decades that simple, unsophisticated, non-engineered, timber and masonry structures (seemingly more medieval than modern) are less safe in large earthquakes than newer structures of reinforced concrete (RC). Despite the frequently abysmal record of contemporary RC structures under seismic loading, certain types of traditional masonry structures with timber-lacing have survived the same earthquakes with only minor damage. This gives rise to the question of whether one can employ aspects of traditional technology Fig. 1 to enhance the seismic performance of modern constructions.

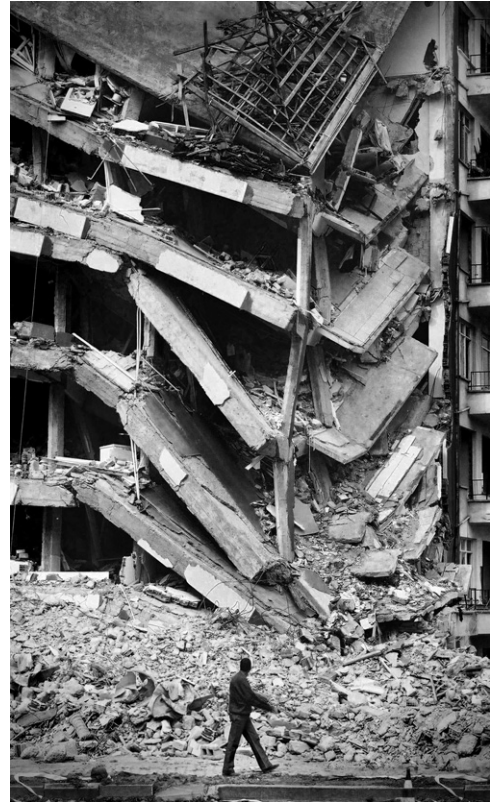
Fig. 2. Partially collapsed RC frame with infill masonry apartment block, Gölcük, Turkey, 1999.

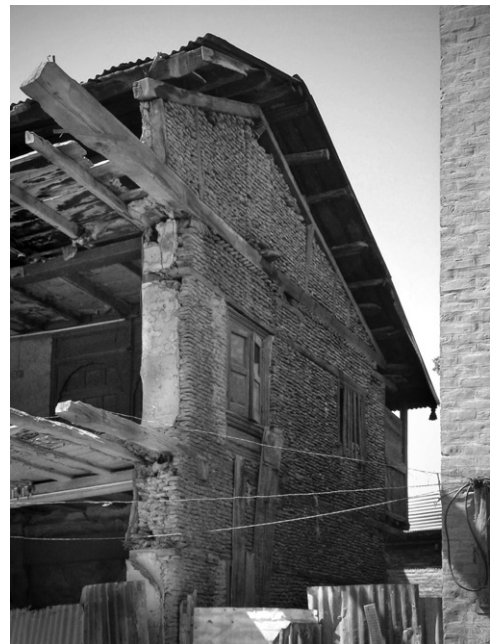
Fig. 3. Partially demolished *taq* construction (Srinagar, Kashmir, 2006) showing timber lacing laid into the wall. Timber bands at floor level and at the window lintel levels.
