Fluctuations in the indoor environment in Spanish rural churches and their effects on heritage conservation: Hygro-thermal and CO₂ conditions monitoring

San Juan Bautista Church (thirteenth–sixteenth centuries) at Talamanca de Jarama, a town 45 km N-NE of Madrid, Spain is a representative example of such historic buildings. It has been a listed monument since 1931. While this church can seat up to 300 seated people, it is scantily occupied most of the year (50–150 people), with a full congregation normally only for services on significant religious holidays (Christmas, Easter, local festivities and so on). Normal mass hours consist of one service each on Friday and Saturday evenings and two on Sunday mornings. The low efficiency of its centralised and intermittent warm-air heating system installed in 1972 [30,31] has led to its mere occasional use for 1–2 h four to five times a week (Friday through Sunday; ~5–6 h/week) from November through April. In recent years considerable

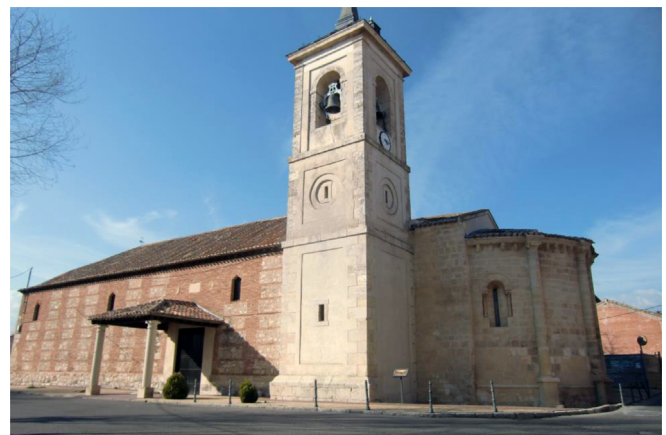
San Juan Bautista Church was built in the twelfth–thirteenth centuries (Romanesque style) with dolostone ashlar. It was reconstructed in the sixteenth century (Renaissance style) with rubble stone and mortar, brick and an earth fill (Fig. 1). The apse and presbytery (high altar) are all that remain of the original church. The main body or nave, enlarged in the sixteenth century, has a rectangular floor plan (27 × 12.5 m) and is divided into three aisles with variable heights: 10.5 m in the middle aisle and 9 m in the two side aisles. The floor is 90 cm below the base of the high altar. The church lies at 30–50 cm below street level. The walls are 50 cm thick in the main body and 60 cm in the high altar. In 1885, when the church was in ruins, the south wall and bell tower were rebuilt, and a new choir was added over the west entrance. The present structure consequently has a 393 m² footprint and contains 3952 m³ of air.

Fig. 1. San Juan Bautista Church (twelfth–sixteenth centuries), Talamanca de Jarama, Madrid, Spain.
