## Influence of paints on drying and salt distribution processes in porous building materials

Teresa Diaz Gonçalves<sup>a,\*</sup>, Leo Pel<sup>b</sup>, José Delgado Rodrigues<sup>a</sup>

<sup>a</sup> Department of Materials, National Laboratory for Civil Engineering (LNEC), Avenida do Brasil 101, 1700-066 Lisbon, Portugal

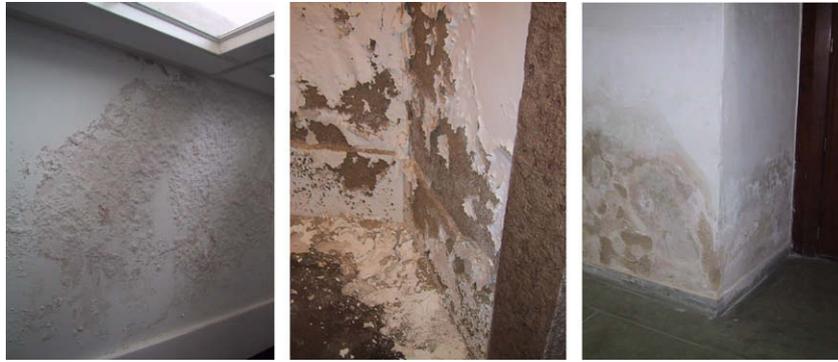
Fig. 1. Different types of surface damage due to salt crystallization: efflorescence (left), physical damage to materials (centre) and dampness (right).

Old buildings are generally built of thick solid masonry walls of porous and very absorbent materials. These buildings are frequently affected by salt decay problems that require appropriate interventions to solve, or at least minimize, such problems. However, professionals involved in the conservation of old buildings claim that salt damage features are often worsened, rather than minimized, after restoration interventions, even when they were specifically carried out to solve salt decay problems [1]. This common statement refers essentially to an increase of surface damage (Fig. 1).
