Seismic vulnerability of historic Dieh–Dou timber structures in Taiwan

Dina F. D’Ayala*, Pin Hui Tsai

Department of Architecture and Civil Engineering, University of Bath, Bath, UK

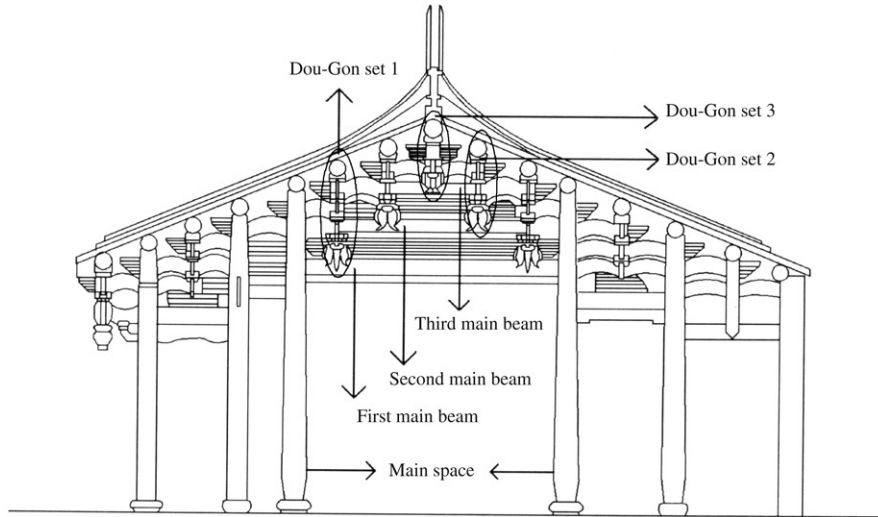
Fig. 1. Schematic illustration of a Dieh-Dou timber frame modified from [3].

A temple compound typically includes several buildings and each building consists of two timber plane frames with the same layout supporting a system of purlins and connected to perimeter masonry walls laid in the direction normal to them. When used in temples, the main objective for the carpenters is to create a large free central space between the supporting columns. Figs. 1 and 2 show a schematic elevation and a real

Dieh–Dou beam stack of the main space of a Dieh–Dou timber frame containing three layers of brackets. The weight of the roof is transferred from the purlins to the top of Dou–Gon sets. The load is then transferred to the columns (and then to ground) through three orders of beams connected with the Dou–Gon sets, as shown in the figures.

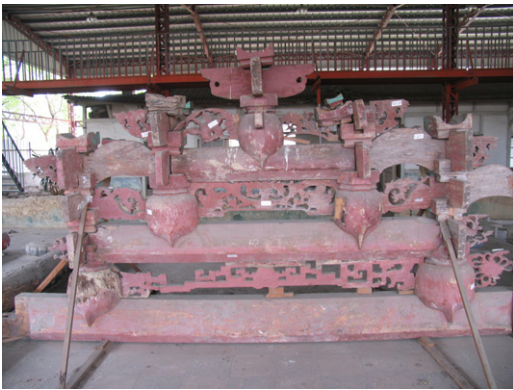
Fig. 2. Timber frame of main space of Guan-Shi family temple.

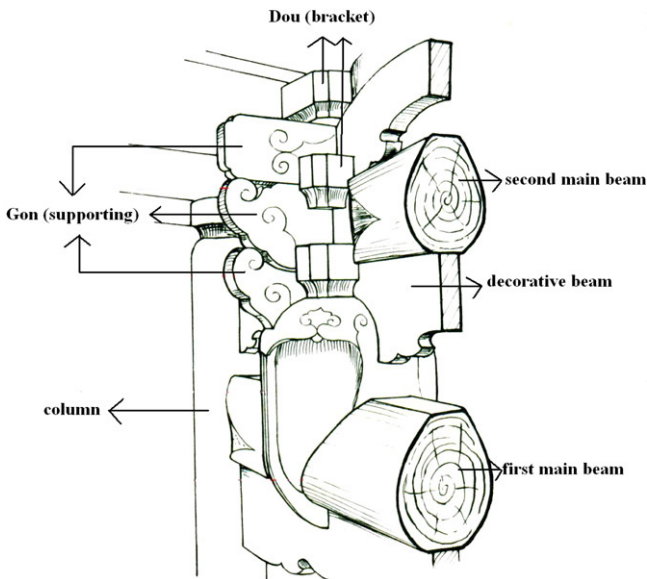
Fig. 3. Detail of Dou-Gon set modified from [4].

The small highly decorated timber elements stacked together to form the Dou–Gon (Fig. 3), are a characteristic feature of this typology, with the role of supporting the purlins and transfer their load to the timber beams and columns of the main frame. Beams and columns in the lower part of the structure are connected by mortise and tenon while the components of the Dou are shaped in double notch joints and connected to the out of plane members by way of shallow dove tails. The in plane bracket connects one Dou–Gon to the next in the plane of the frame, creating the slope of the roof, while in its concavity accommodates the round purlin. The system of transversal round purlins connecting the two adjacent frames provides out of plane stability and it is further stiffened by the out of plane brackets. Lateral forces, such as wind uplift or accidental impact, are counteracted by the substantial weight of the roof; however, this also represents a large mass that

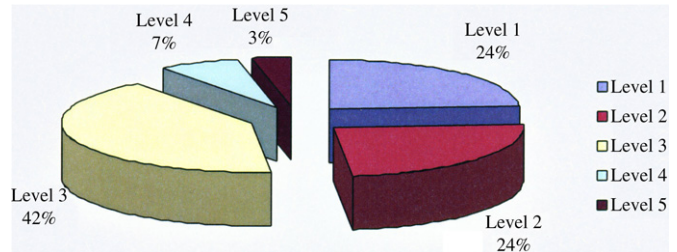
Fig. 4. Level of damage of Dieh-Dou buildings after Chi-Chi earthquake.

Such inherent seismic vulnerability was clearly highlighted by the widespread damage caused to this type of structures by the 1999 Chi-Chi earthquake of 7.3 Richter Scale. According to Chang [2], only 7% of timber buildings showed little damage, while most buildings were seriously damaged (45%) or collapsed (48%). However, these statistics did not classify the timber buildings by structural type. Further investigation carried out within the present project, identified at least 52 historical architecture compounds built as Dieh-Dou structures over the Chi-Chi earthquake stricken region; however, for 29 of them it was not possible to gather data about their condition after the event. For the remaining 23 Dieh-Dou compounds, Fig. 4 shows the level of damage that was identified. Level 1 means no damage. Buildings with elements pulling out from joints and roof decorated ridge damage are in level 2. Level 3 is the case of eaves rupture, masonry wall cracks and columns sliding from the original position, which are not considered an immediate threat to collapse. Finally, buildings leaning and collapsed are classified as damage level 4 and 5, respectively.
