Using advanced NDT for historic buildings: Towards an integrated multidisciplinary health assessment strategy

2. Case study (Urla primary school)

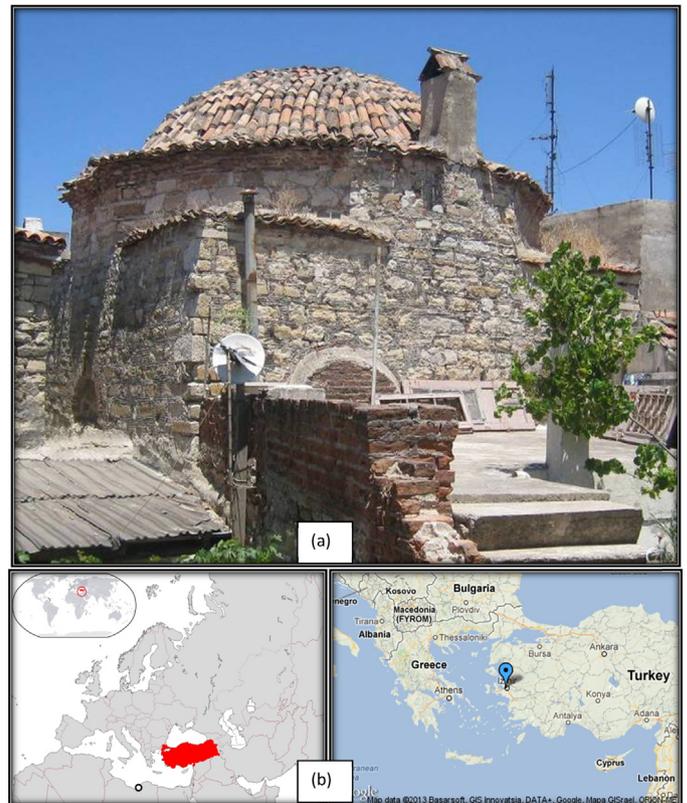
Fig. 1. a: view of the Urla primary school; b: location.

The case study building is an Ottoman structure, which currently houses the Urla primary school (Fig. 1a). The building offers an ideal case study for this research, in view of the fact that minimal structural paperwork has survived. As such, the value of the multidisciplinary technique described can be assessed.

This sixteenth century building is situated in Urla, Izmir (Fig. 1b) and a south plan view can be seen on Fig. 2.

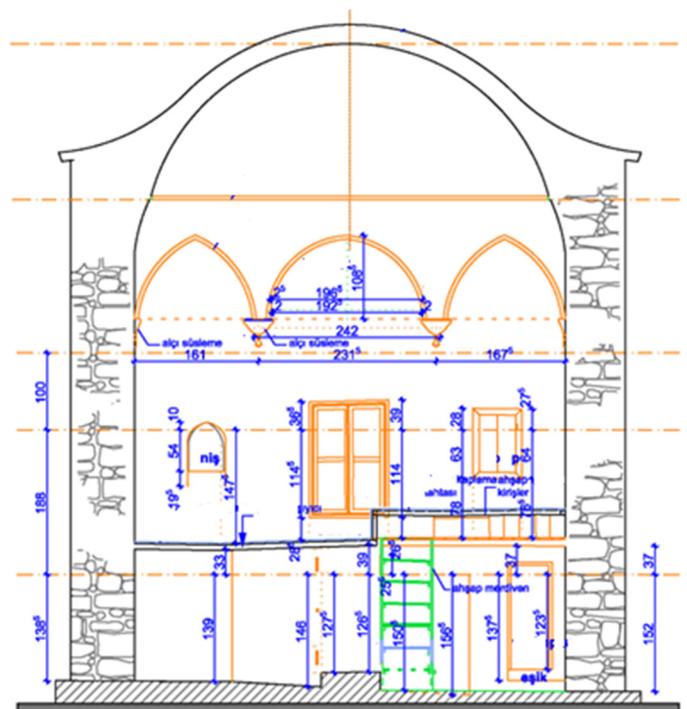
Fig. 2. South plan view of the Urla primary school AutoCAD drawing [34].
