# Numerical characterization of the structural behaviour of the Basilica of Pilar in Zaragoza (Spain). Part 1: Global and local models

**Keywords:** Historical buildings; Masonry; Structural models; Visualization; Finite element analysis; Non-linear material

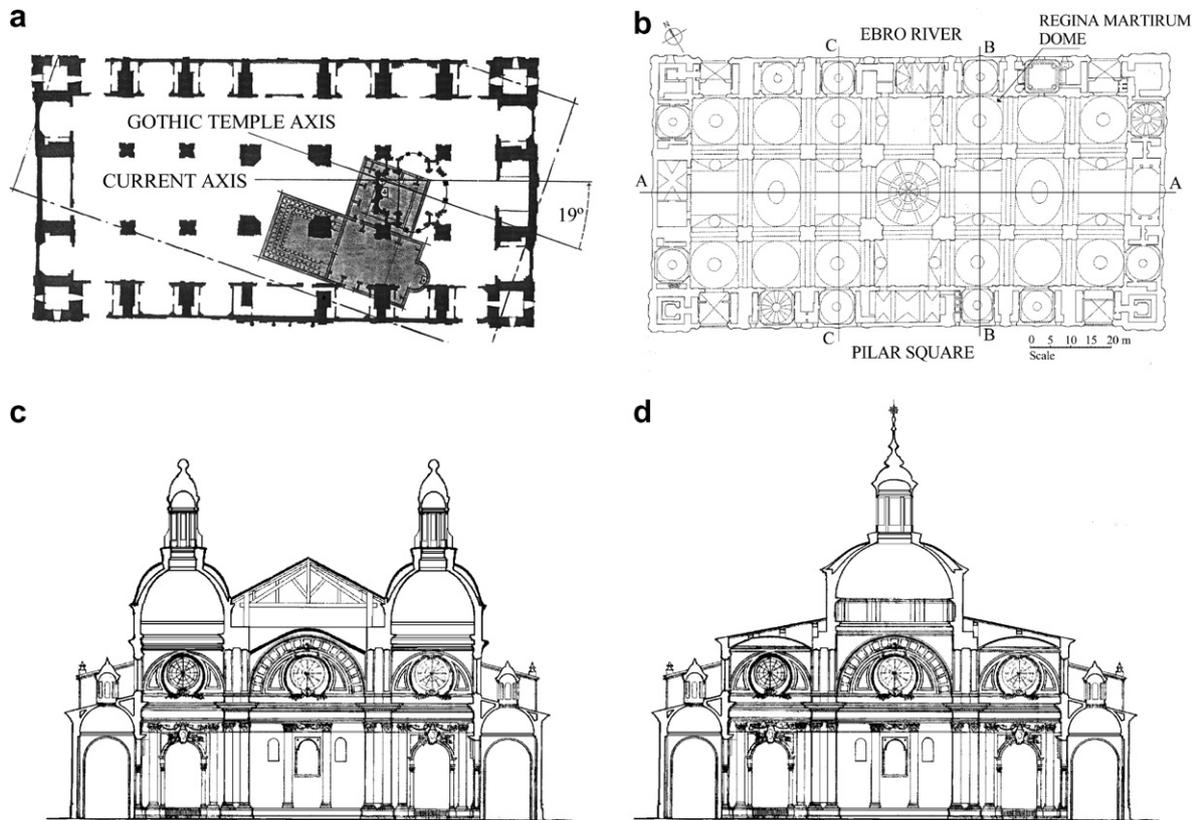
Fig. 1. Plans: (a) evolution of the worship site; (b) inferior top view; (c) front section BB for the Regina Martirum dome; (d) front section CC for the elliptical dome.

in XVII century when the Baroque church project was set up by the Spanish architect Ventura Rodriguez. In addition a reorientation to the main axis of the temple took place and part of the new construction was erected on terrain taken to the adjacent river. Fig. 1a presents a sketch describing the position of each building along the history and some plans; Fig. 2 shows several views of the actual Basilica.

The temple is composed of three longitudinal naves (Fig. 1b). The central one contains the main dome of circular design and double shell, and two more domes of elliptical shape (Fig. 1d). The two lateral naves have eight more domes placed at a second level, the Regina Martirum dome belongs to this second level, located next to the central dome (Fig. 1c). Surrounding the principal naves there is a series of chapels and rooms with up to 11 additional domes at the third lower level. The domes at the third level are located between the 16 external buttresses and the four towers, of more than 90 m height, that mark the corners of the building and form the external perimeter. The
