Seismic rehabilitation of semi-rigid steel framed buildings—A case study

This paper presents the seismic vulnerability and rehabilitation of a steel building with semi-rigid connections in Tehran. This 19-storey building with an asymmetric plan was constructed 30 years ago in three blocks. The qualitative vulnerability of the building was evaluated in the first step of the study, indicating its high seismic vulnerability. In the next step of the study, the quantitative vulnerability of the structure was investigated. The results show that the building was strong enough to resist gravity loads but the strength was not adequate for seismic loads. Finally, three seismic retrofitting methods consisting of concrete shear wall, steel shear wall, and steel bracing were proposed. The comparison of the three retrofitting alternatives in terms of architecture, implementation, and seismic performance showed the superiority of using the concrete shear walls over the two other alternatives.

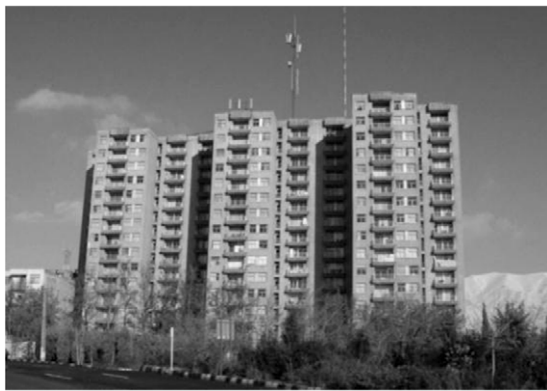
Fig. 2. The southern view of the building.

blocks. There was a distance of about 21 cm between the blocks. The blocks consisted of 19 stories: 3 underground stories, the ground floor and 15 stories on the ground. The area of each storey was approximately 1950 m². The three underground stories were used as car parking areas and the upper floors, being offices for roughly 2000 people, had an administrative usage. The typical storey height was 3.2 m. The southern view of the building is shown in Fig. 2.
