International Journal of Fatigue

Effect of electrical discharge machining on corrosion and corrosion fatigue behavior of aluminum alloys

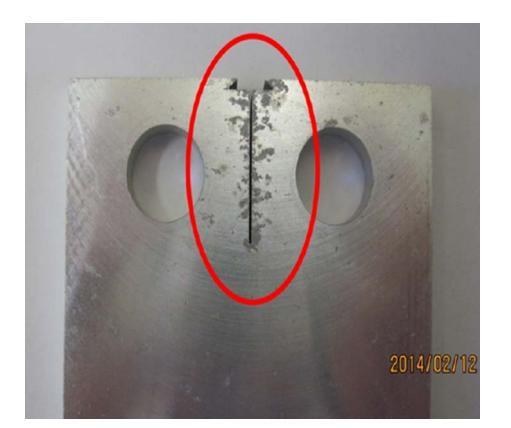
Fig. 1. C(T) specimen after two months outdoor exposure at Daytona Beach.

During an outdoor exposure at the Battelle Outdoor Exposure Facility in Daytona Beach, FL, a 5083-H116 aluminum alloy compact tension sample (C(T)) exhibited corrosion damage near the notch, Fig. 1. The notch on the sample had been electrical discharge machined (EDM), while the other sample surfaces had been milled. Based on a visual examination of the sample, it appeared that the 5083-H116 test coupon suffered corrosion damage on the surface adjacent to the EDM notch, while the milled surface was not affected as severely by the environment. The ellipse in Fig. 1 highlights the accelerated corrosion around the EDM notch. Accelerated corrosion around an EDM notch on a laboratory fatigue specimen raises concerns about the impact of manufacturing methods on corrosion performance, and in turn environmentally assisted crack growth testing. Such preferential corrosion damage on a critical location of a test specimen could produce error in damage predictions or material properties based on laboratory testing of specimens.
