11th Nordic Symposium on Building Physics, NSB2017, 11-14 June 2017, Trondheim, Norway

Achieved Energy and Climate Goals in Project Ålidhem: An Evaluation of a Refurbishment of 21 Swedish multifamily Buildings

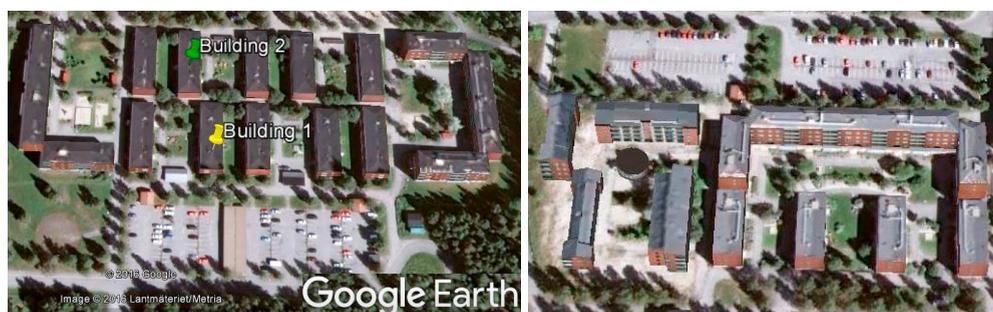
Fig. 1.(a) 3D model of one block of buildings in the project area including case study buildings, Building 1 and Building 2, Fig.1.(b) 3D model of the second block of buildings in project area. Both models were created with the help of Google Earth [7].

The project area is shown in Fig.1 and includes 21 multifamily buildings, (buildings with common outer walls have been counted as one building). The buildings were built during the years 1970-1971 and initial measurements indicated a high average specific energy use as well as a low indoor comfort in the area. Therefore, a number of ECMs was decided to be included in the refurbishment. In order to decide suitable and cost-effective ECMs for the project a test-building, referred to as Building 1 was initially evaluated. The evaluation of energy savings (building level) was done through a comparison with a similar building, Building 2 in which no measures were undertaken at the time (a comparison possible through very high building similarities). Building 1 and Building 2 can be seen marked in Fig. 1.
