Special Issue Article: The First International Symposium on Mine Safety Science and Engineering

Stability and deformation of surrounding rock in pillarless gob-side entry retaining [☆]

Zhang Nong ^{a,*}, Yuan Liang ^b, Han Changliang ^a, Xue Junhua ^b, Kan Jianguang ^a

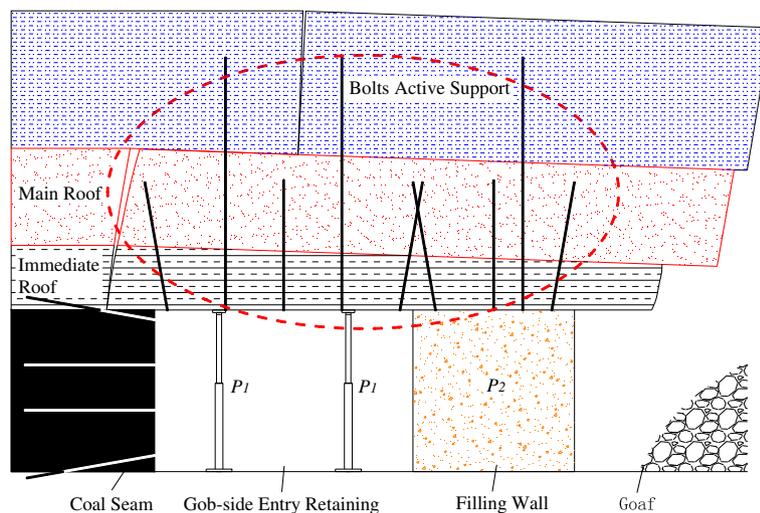
Fig. 1. The “three-in-one” control principle of gob-side entry retaining.

The primary bolt support, the supplementary support in the roadway and the backfilling along the roadway constitute the “three-in-one” surrounding rock control technology of gob-side entry retaining (Fig. 1). The bolt support and hydraulic prop provide active support to achieve pre-tension or high initial load, whereas the backfilling along the roadway comes into effect only when the amount of roof subsidence offsets the amount of the insufficient roof-contact. Therefore, in the calculation of roof support strength, the capacity of bolt and hydraulic prop support are considered, and in the calculation of coal sidewall support strength, only the capacity of pre-tensioned bolts is considered. Mining section and supporting parameters of gob-side entry retaining are shown in Table 2.
