An investigation of the moisture content in the walls of a straw-bale building

Steve Goodhew^{a,*}, Richard Griffiths^b, Tom Woolley^c

^aUniversity of Plymouth, School of Engineering, Devon, Plymouth UK

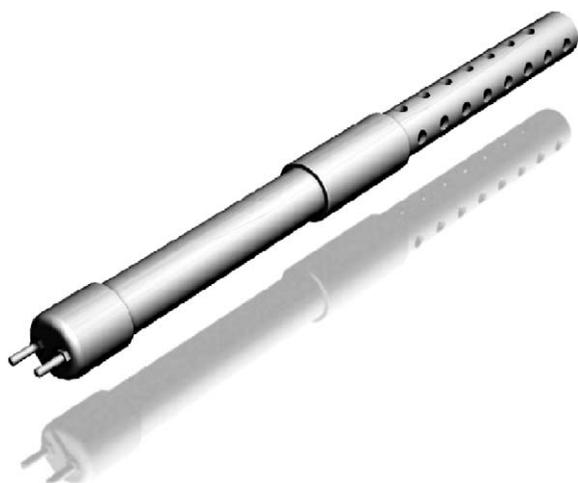
Fig. 1. Illustration of a typical wood-disc moisture probe (drawn by Neill Hughes).

The wood-disc moisture probe chosen is based upon the work carried out by Canada Mortgage and Housing Corporation and is advocated by Gonzalez of the University of British Columbia [8] and Woolley of Queens University Belfast [9] (Fig. 1).

The wood-disc moisture probes, of area 25 mm² were constructed of wood 5-mm thick. The block is drilled in 2 places to make holes 5 mm apart, although the exact distance is unimportant [10]. Two stainless-steel screws are then inserted with a stripped end of a piece of wire wrapped around the head of each screw. The wood-disc is then placed at the end of a PVC tube with ventilation holes made around it. The tube can vary in length depending upon how deep into the wall it is being placed. The two wires are then run the length of the tube and left protruding out of the end. These will be outside the building, ready for readings to be taken. Readings are taken using a 'Protimeter' Wood

Moisture Meter calibrated for wood. The moisture content of the wood-disc within the probe is influenced by the relative humidity of the bale via the vent holes in the PVC tube. In this way the moisture content of the bales may be assessed.
