# Using multi-scale entropy and principal component analysis to monitor gears degradation via the motor current signature analysis

This paper describes an approach for identifying localized gear tooth defects, such as pitting, using phase currents measured from an induction machine driving the gearbox. A new tool of anomaly detection based on multi-scale entropy (MSE) algorithm SampEn which allows correlations in signals to be identified over multiple time scales. The motor current signature analysis (MCSA) in conjunction with principal component analysis (PCA) and the comparison of observed values with those predicted from a model built using nominally healthy data. The Simulation results show that the proposed method is able to detect gear tooth pitting in current signals.

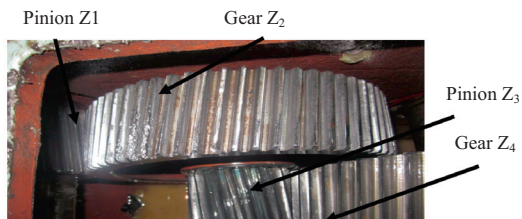
Fig. 3. The gearbox experimental system.
