Engineering Structures

# Seismic evaluation of Romanian traditional buildings with timber frame and mud masonry infills by in-plane static cyclic tests

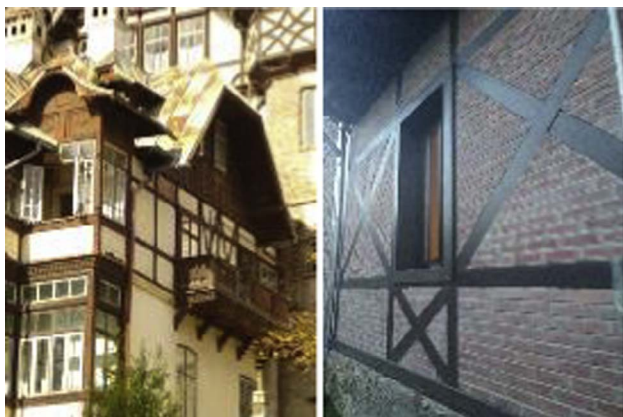
Fig. 1. Old (left) and new (right) "Fachwerk" architecture in Sinaia city, Romania [1].

In Romania, there are places where the buildings with infilled timber frame structure are inspired by the German "Fachwerk" traditional buildings, as there are in Sinaia city and its surroundings (Fig. 1). However, this area is not considered pure traditional Romanian, so the studies did not go further on this direction.

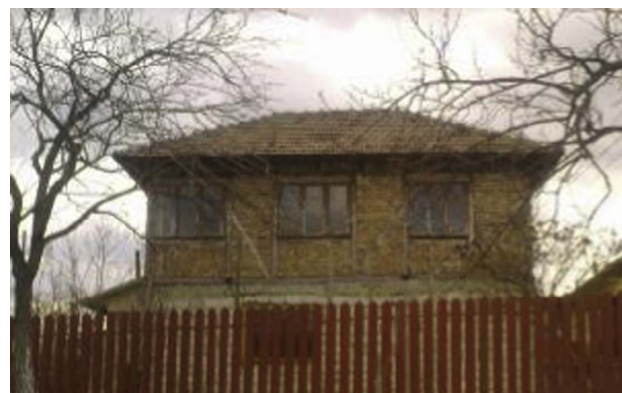
Fig. 2. Traditional infilled timber frame house from Buzau county [4].

Also, there are other places, in rural areas, where people build this type of structure due to the local tradition of the area, such as Buzau or Vrancea county area [personal communication] (see Fig. 2). It seems that traditional way of building is actually the result of the adaptation of tens or hundreds of years to local seismic culture [13], but also to raw materials availability.
